London Borough of Waltham Forest

Flood Investigation Report

Borough-wide, Sunday 25th July and 7/8th August 2021

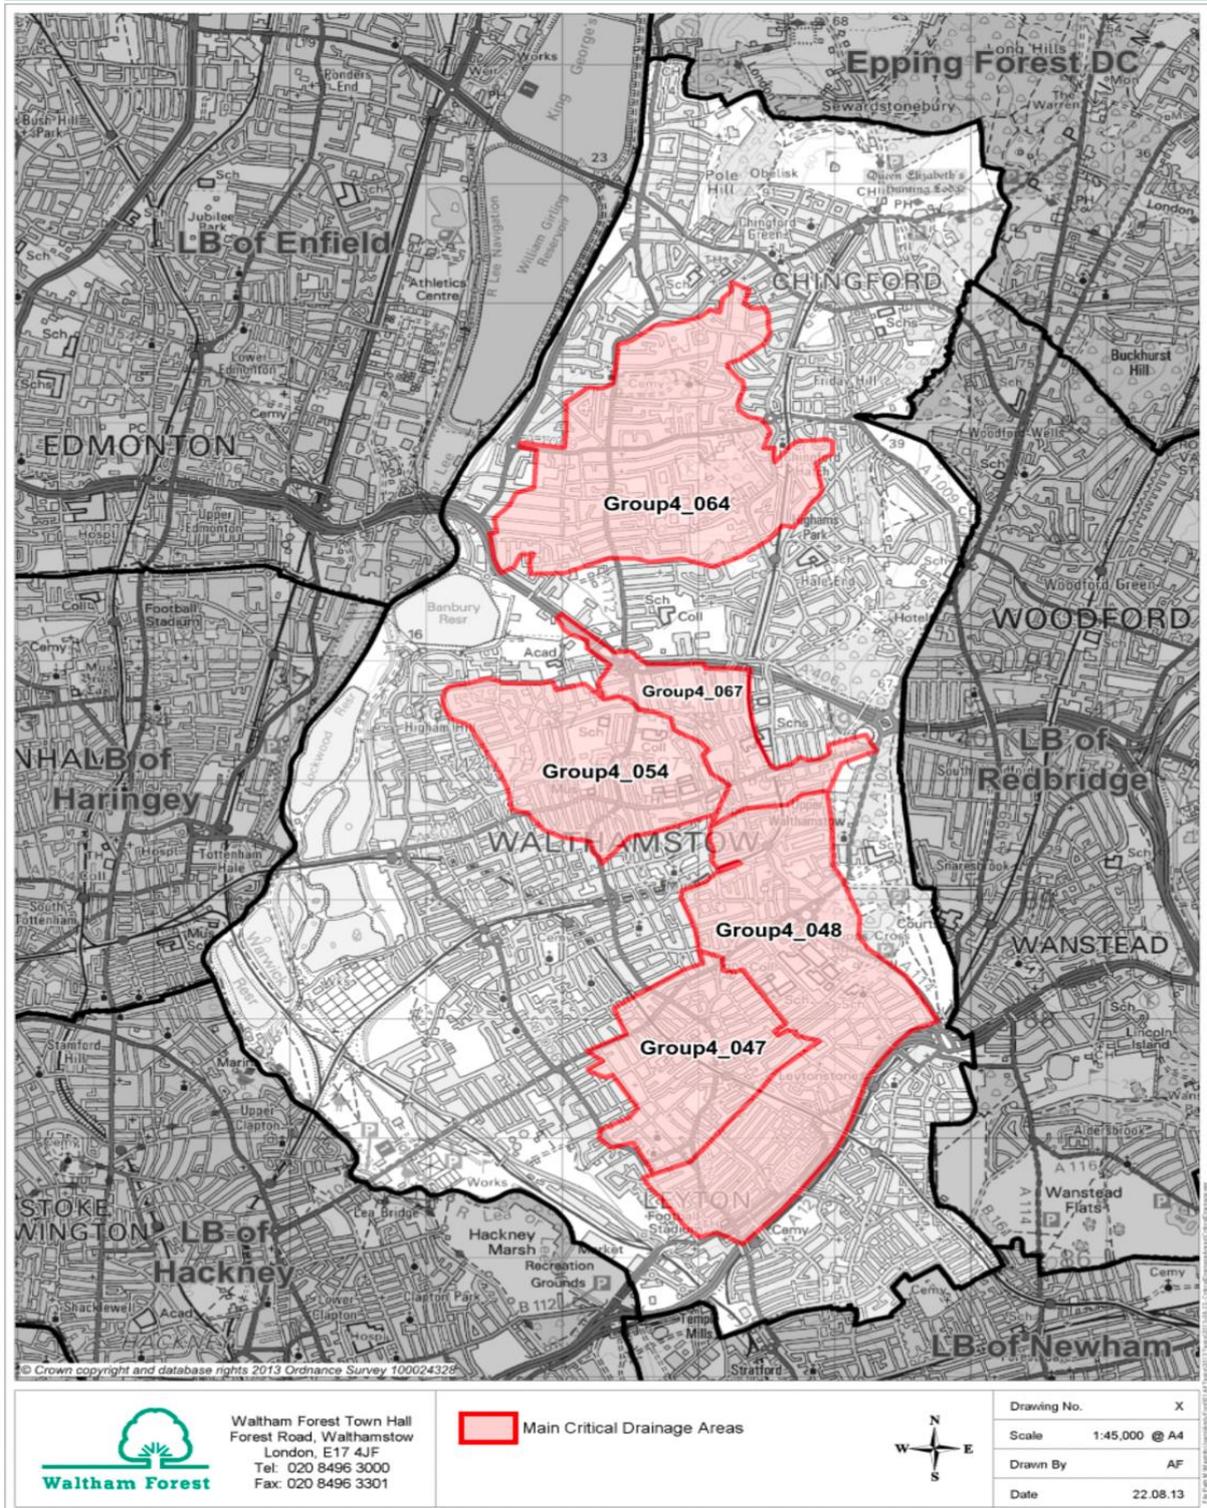
Figure 3: Main Critical Drainage Areas within LBWF

Locations of the 5 main CDA areas as illustrated in Figure 3 below.

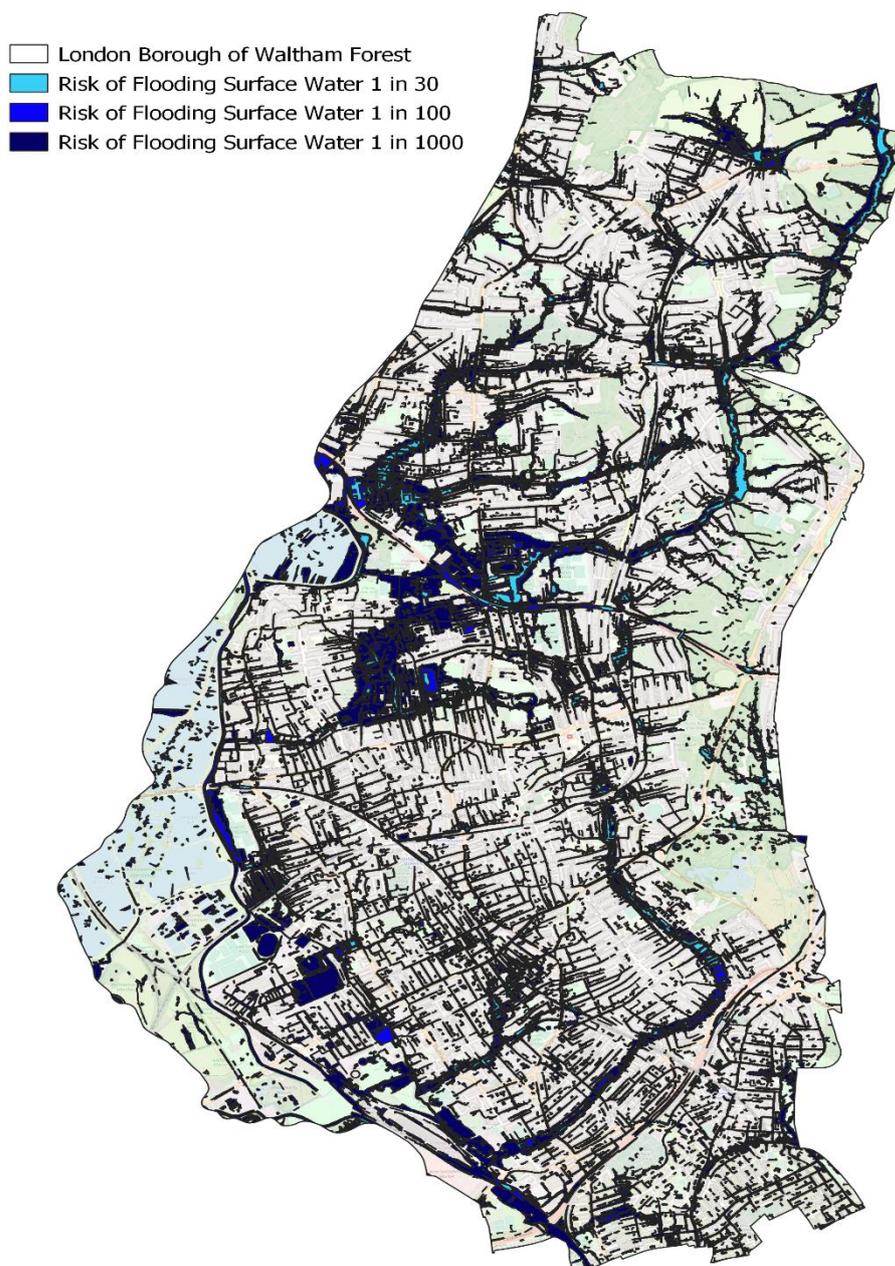
Figure 4: Risk of flooding from surface water, Environment Agency data set

The map above shows indicative areas at risk of surface water flooding during a 1 in 30, 1 in 100 and 1 in 1000-year flood event. A description of flood event return periods can be found in Appendix A. As this map only gives indicative surface water flood risk across the borough, it is not suitable to determine individual property level flood risk.

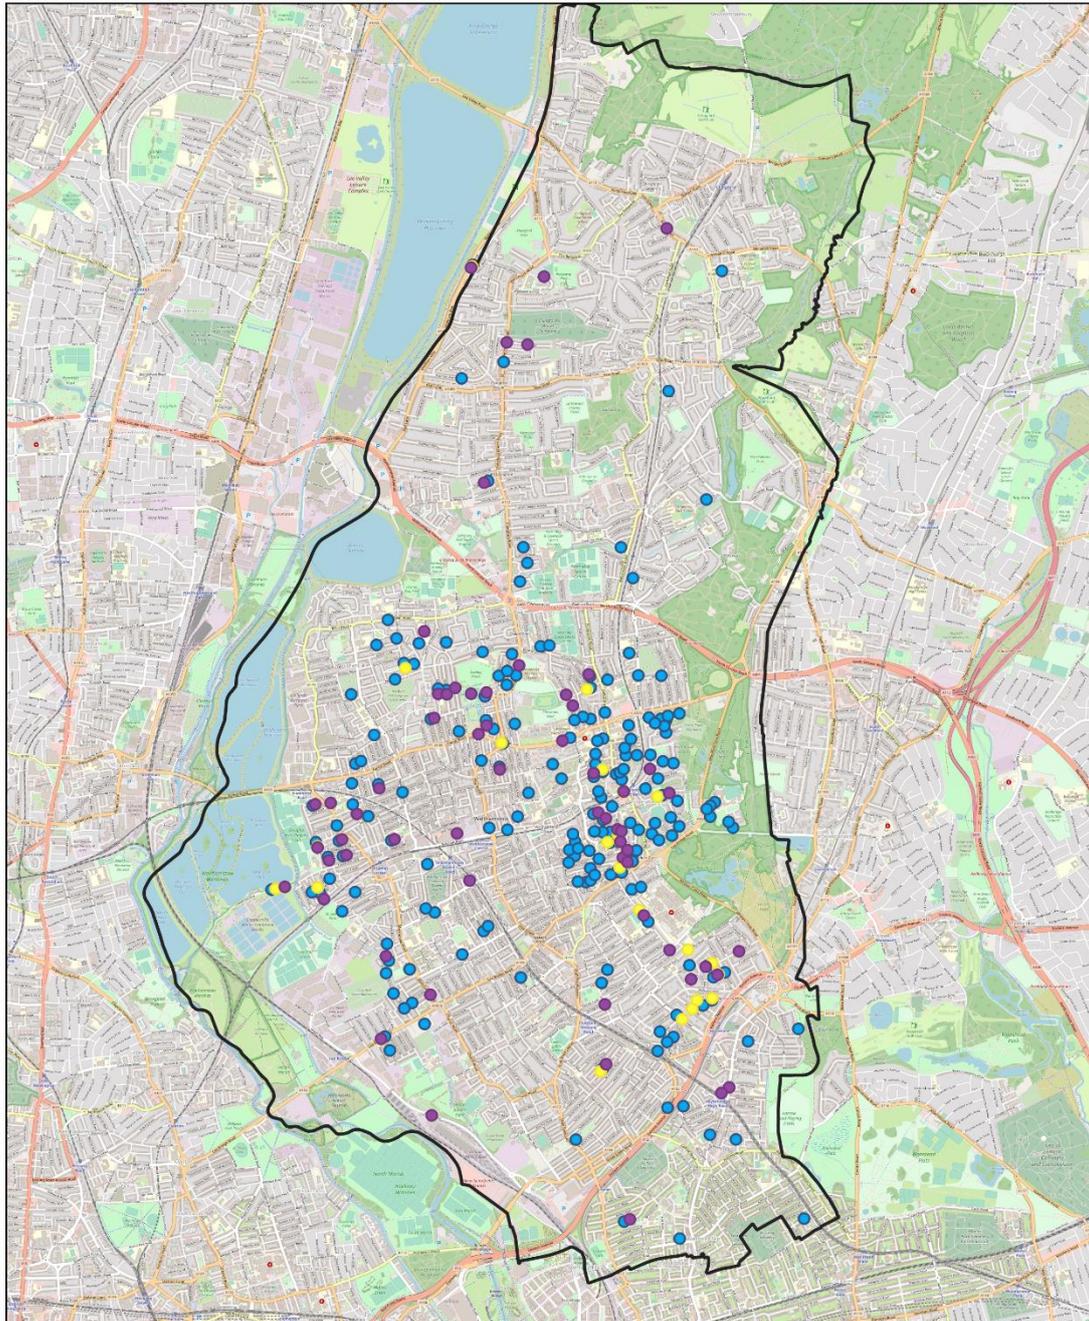
Figure 5: Relevant historic flood records and 2021 reports received

Of the locations reported to have been affected by property flooding in July and August 2021, at least 14 of these have been affected by flooding in the past, based on the Council's historic records. These locations are shown in yellow in Figure 5, and are mainly concentrated around the Wood Street and Upper Leytonstone areas within the Fillebrook CDA. This includes locations such as Brooke Road, Oliver Road, Peterborough Road, Wadley Road, Esther Road and Kings Passage, which have featured prominently in previous flood events. Beyond official Council records there is further historic evidence to support flooding incidents in these locations in the past, as well as anecdotal evidence from residents and stakeholders in these areas, suggesting that flooding has occurred repeatedly over a large number of years.

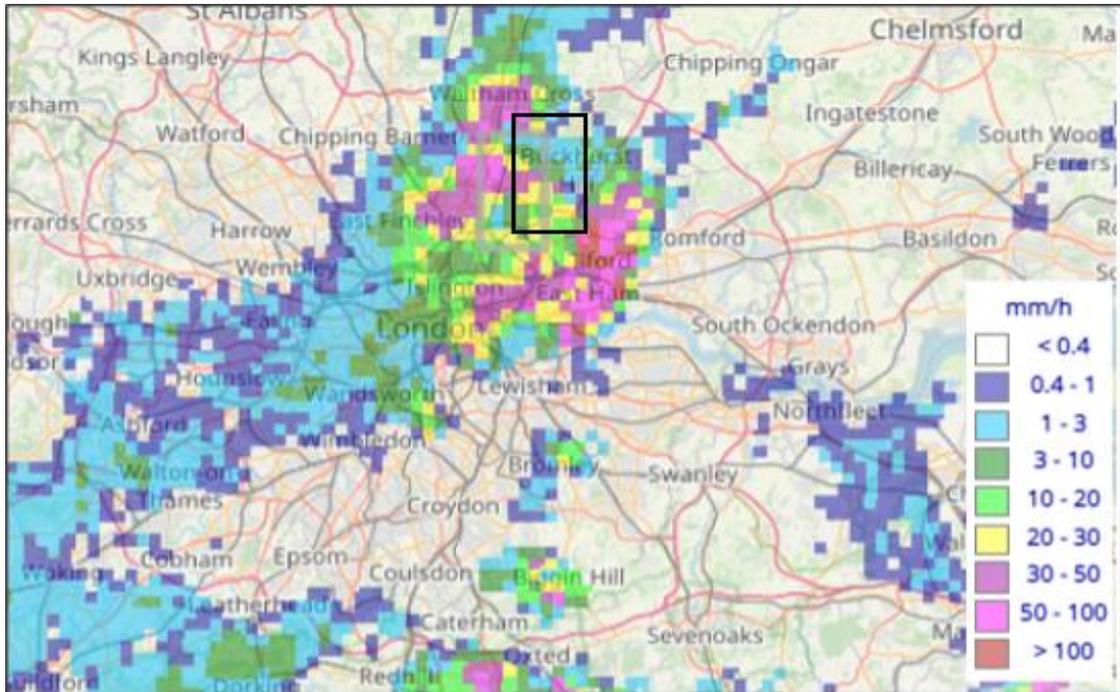
July 25th 15:00 rainfall mm/h

The following radar images give an indication of the storm movement across the borough during the peak of both events, with indicative rainfall in mm per hour. A full set of images can be found in Appendix B.

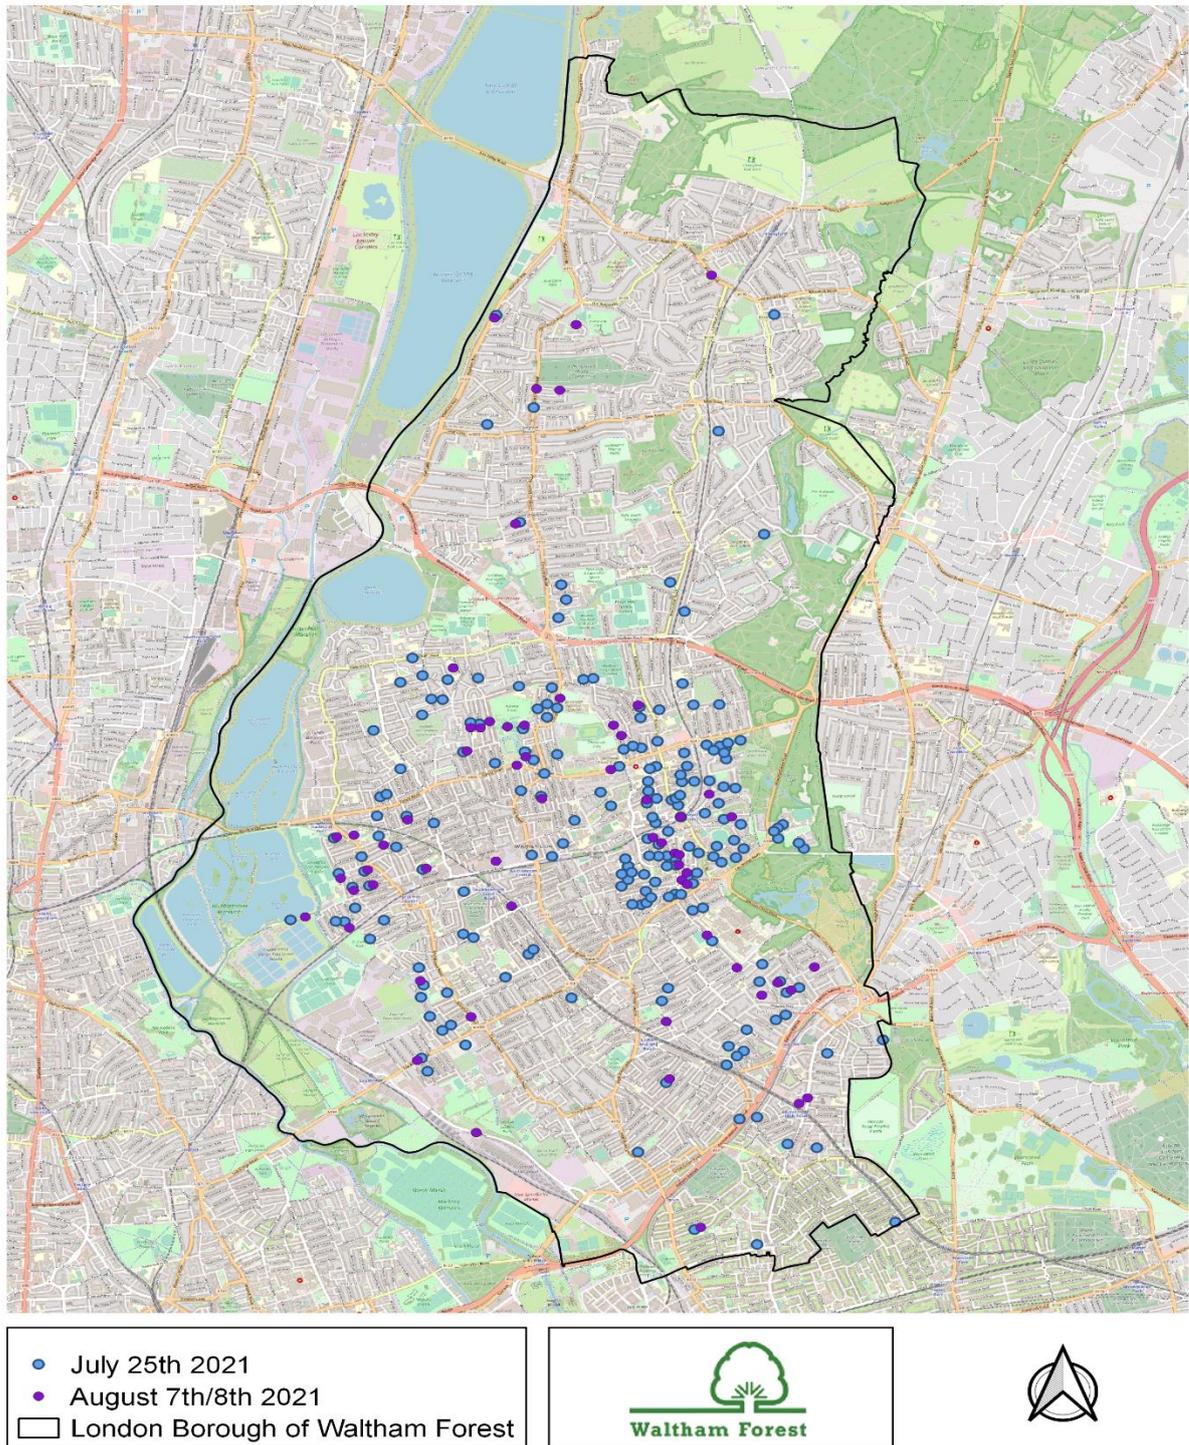
Figure 6: Flooding reports on July 25th and 7th 8th August 2021

The worst affected locations within Waltham Forest were predominantly in the south and east of the borough, with Wood Street Ward being the most heavily impacted followed by parts of Leytonstone, Leyton, St James Street, Lloyd Park, Chapel End and Higham Hill, amongst others. A sizeable proportion of flooding incidents were concentrated around the path of the Fillebrook - a culverted watercourse that runs through Wood Street and Leytonstone before discharging into the River Lea in the southwest of the borough. This included numerous flooding incidents in locations such as Brooke Road, Oliver Road, Peterborough Road, Wadley Road and Esther Road, all of which were severely impacted.

A detailed record of locations subject to flooding across both storm events has been compiled from a range of sources including partner RMA's (primarily TW and the EA), reports made directly to LBWF, and community reports via local Elected Members and on social media. Flooding locations have been plotted as shown on Figure 6 below. A full list of locations is also included in Appendix C.

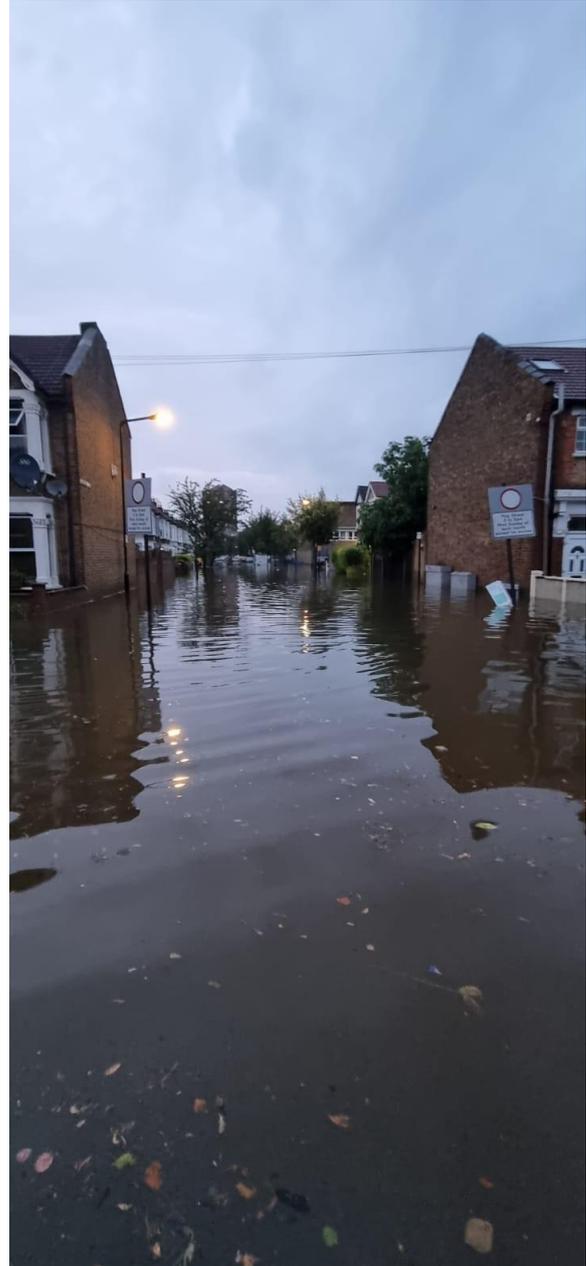
Figure F 7 - Oliver Road 26th July 2021, debris left from flooding

Resident reports have largely been supported by the councils own operational teams, with areas such as Brooke Road, Oliver Road and West End Avenue in particular requiring significant cleansing and waste collection operations following the flooding. During the clean-up process, Council operatives confirmed that almost every household in these areas had items damaged by flooding that required removal.

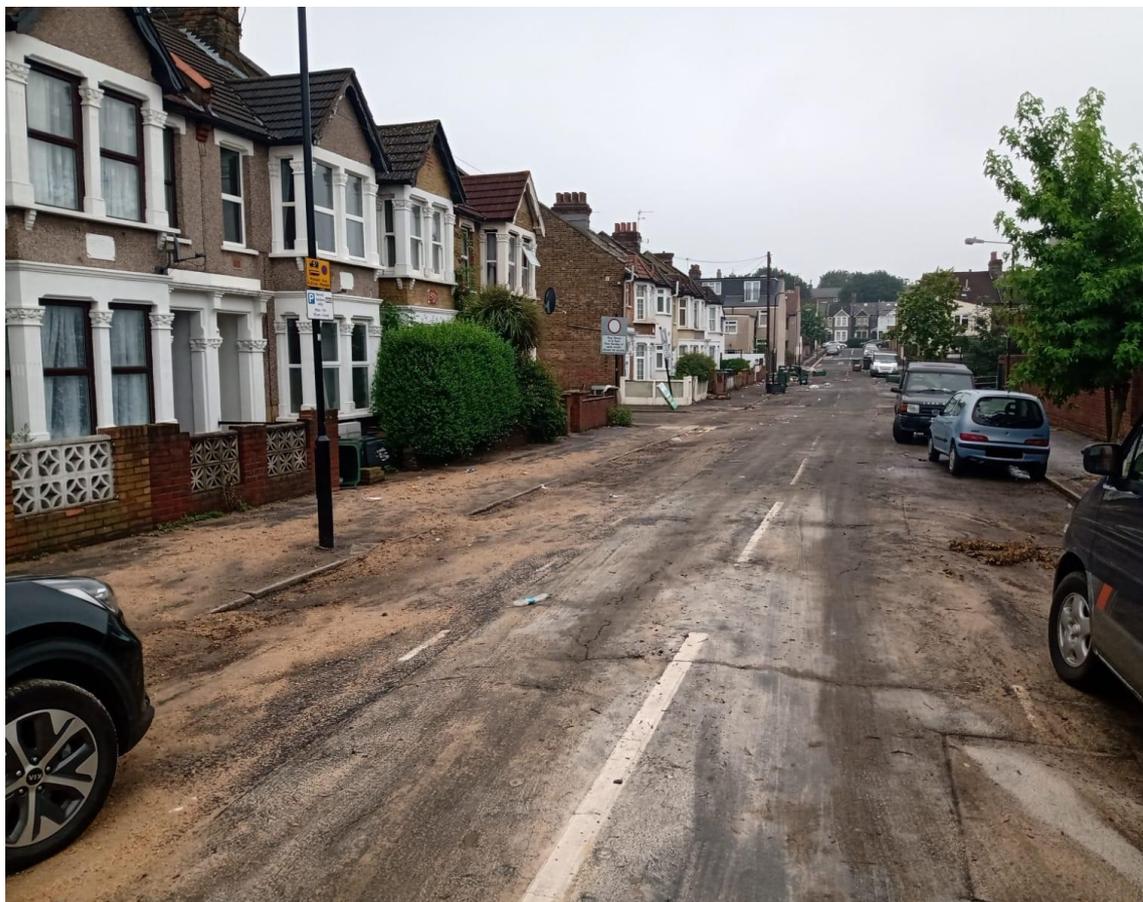
Figure F 8 - Clare Road Forest Road Junction

Extensive flood damage was also reported to the Council by at least 10 residents in Forest Road and Clare Road, which are both situated on the alignment of the historic Fillebrooke river. Reports included cars being submerged and subsequently written off by insurers, alongside the severe internal property damage that was caused. Some residents have reported that they have still not been able to return to their property whilst repairs are being carried out as of February 2022.

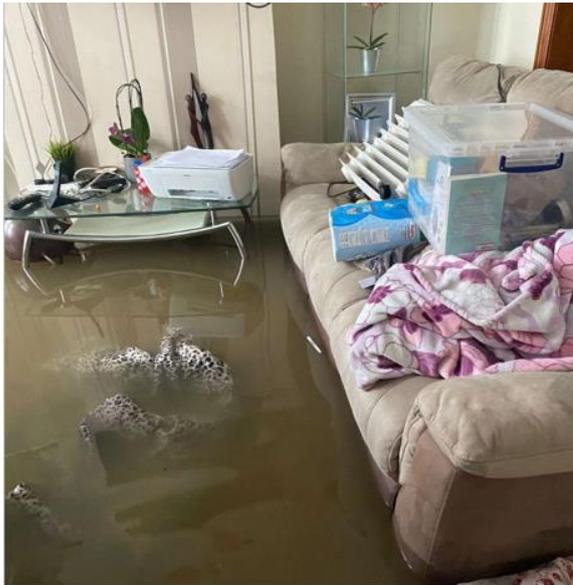
Figure F 13 - Flood damage to home

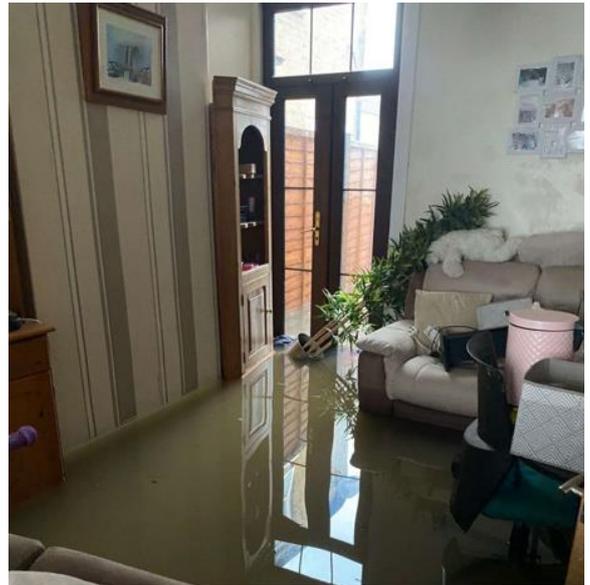
Figure F 14 - Flood damage to home

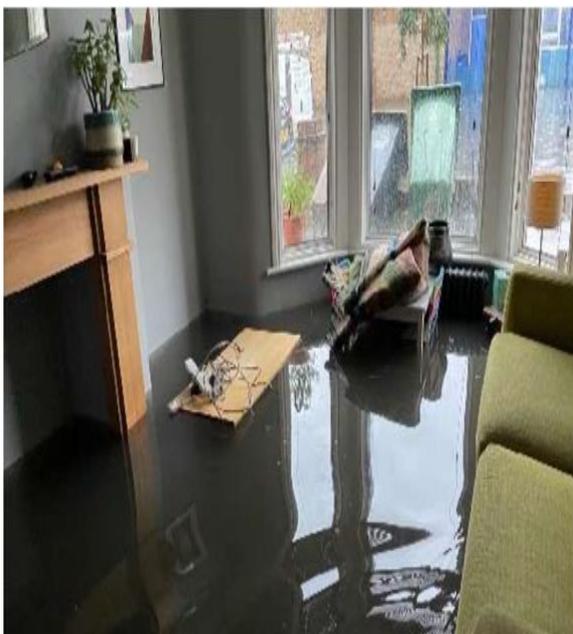
Figure F 15 - Flood damage to home

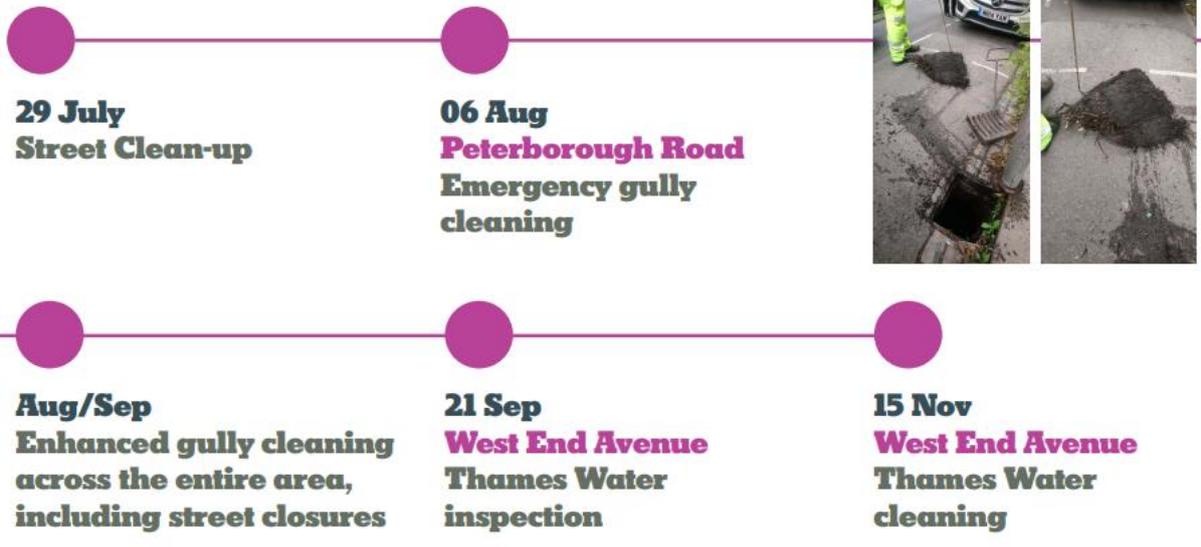
Observations: Peterborough Road

- Rainfall on the day was substantial.
- Gullies were blocked and prevented the water draining after the rain ceased. This must also have resulted in higher water levels.
- At the time the main drains were opened, there was sufficient capacity to drain the floodwater rapidly.

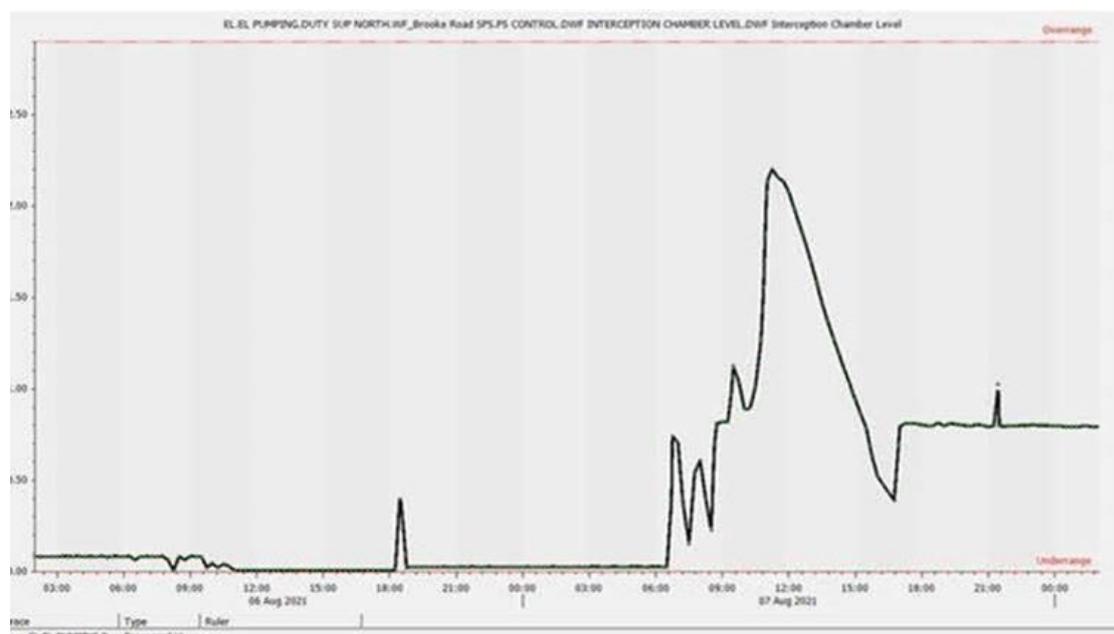
Trends below show discharge chamber level increasing after pumps have stopped indicating the sewer being surcharged due to extreme rain fall.

08:58 – Storm Wet well changed to high.

09:04 – DWF Wet Well changed to high.

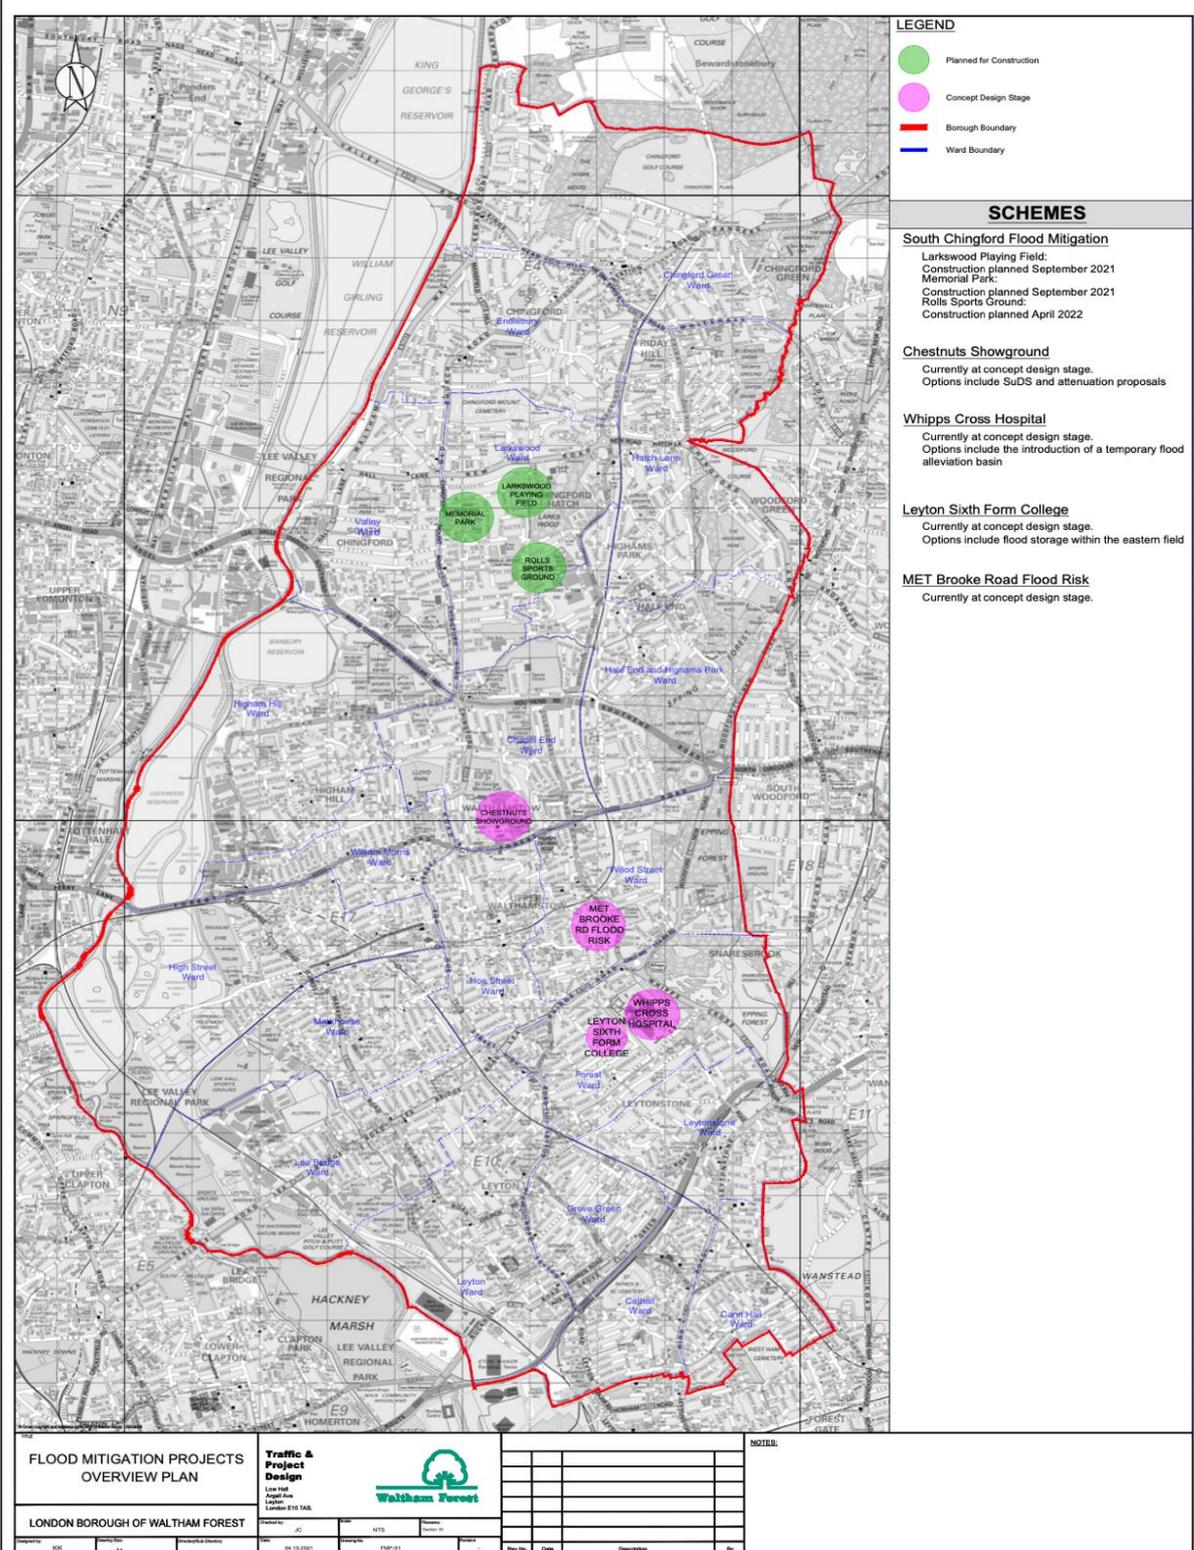
Figure 7: Planned Flood Mitigation Schemes in Waltham Forest Borough

These schemes are mapped in Figure 7 below.

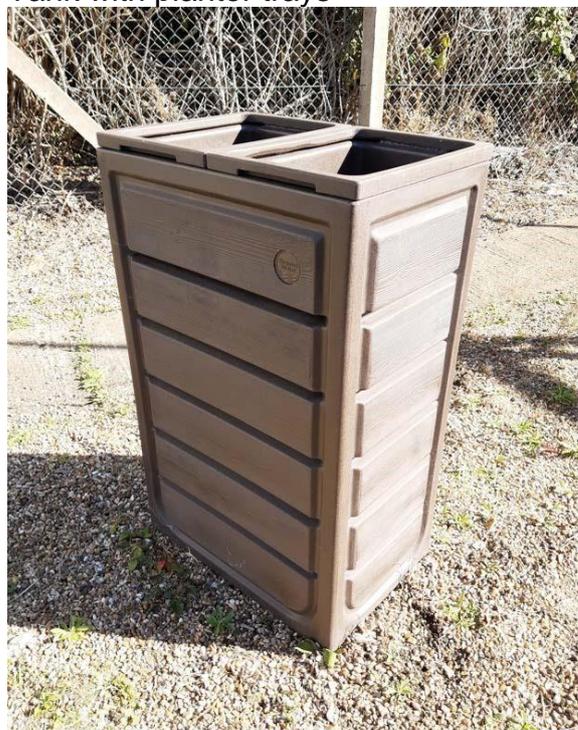
Tank with planter trays

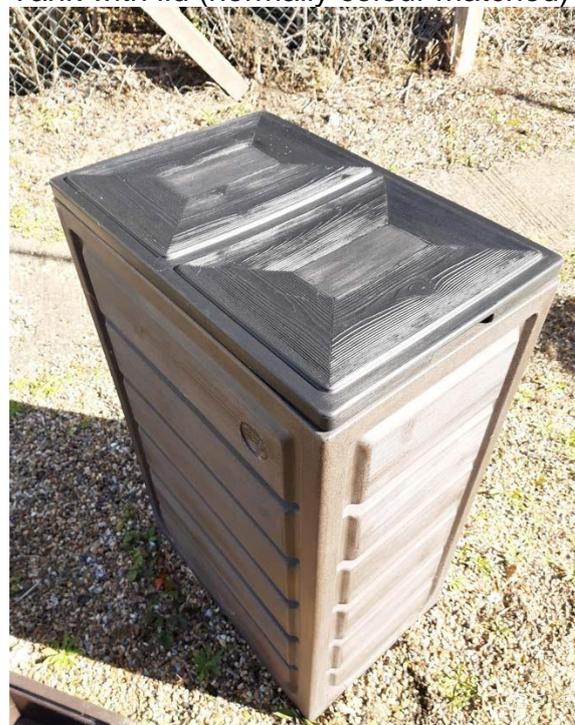
Tank with lid (normally colour matched)

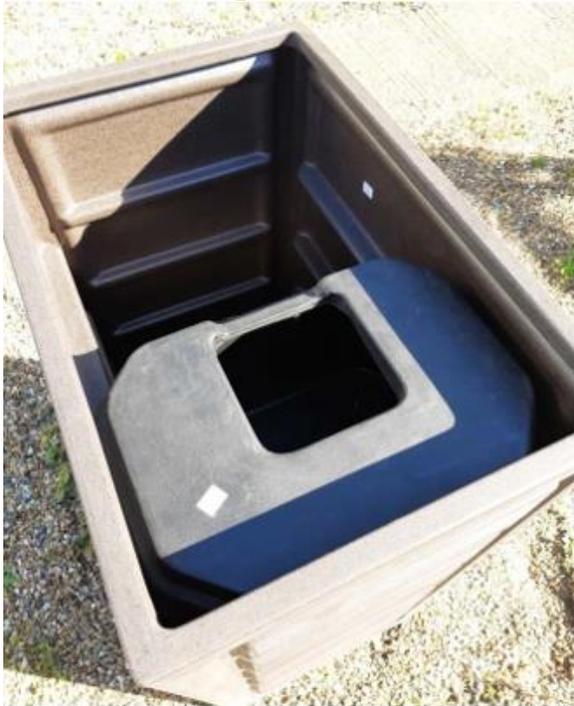
Inner tanks at higher level if lid used

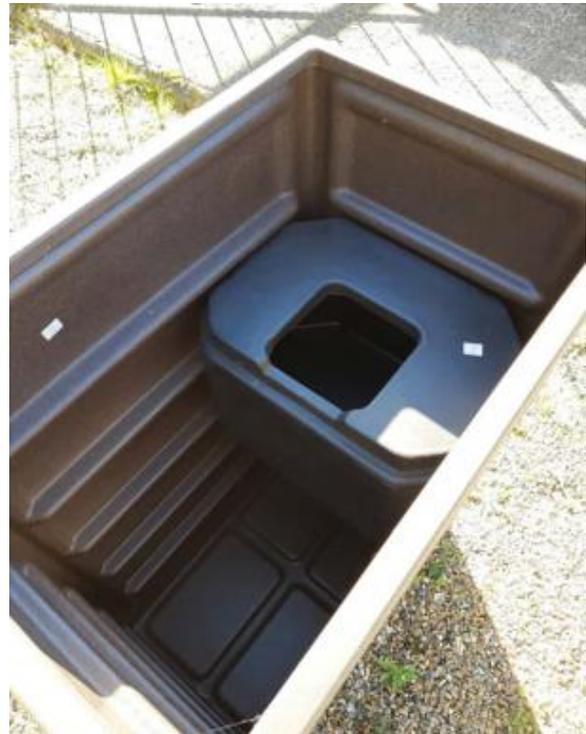
Inner tank at lower level if planter trays used

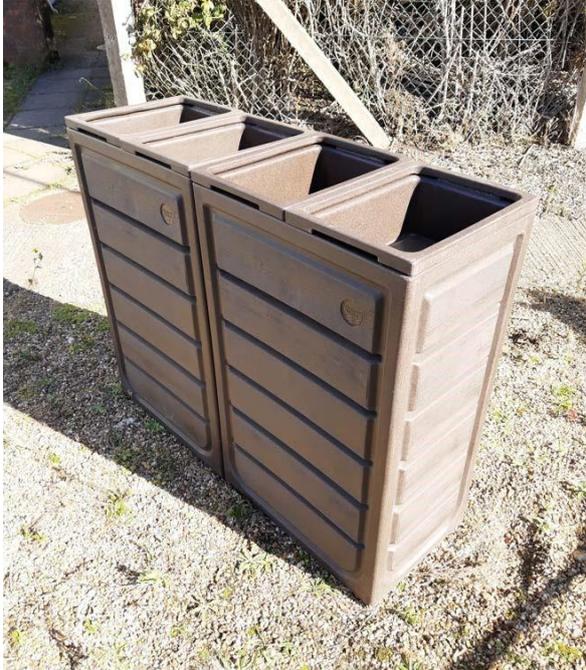
Planter tanks can be joined along short side (400 x 1200mm)

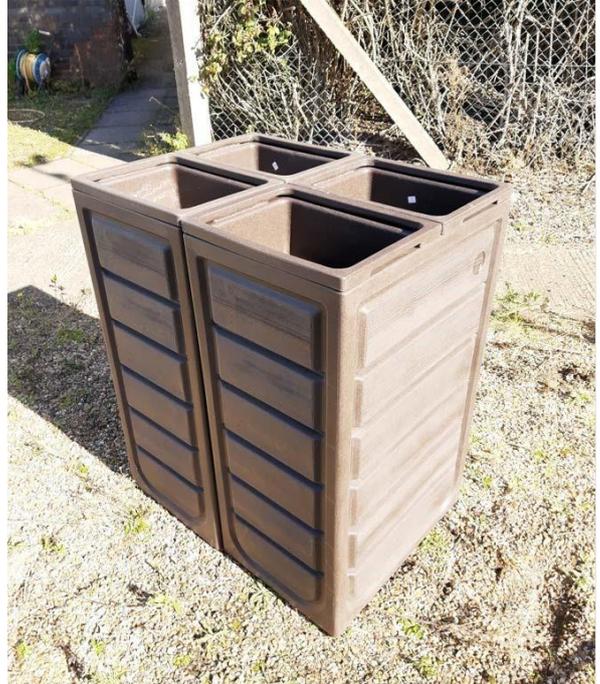
Planters joined along long side (800 x 600mm) or more if needed

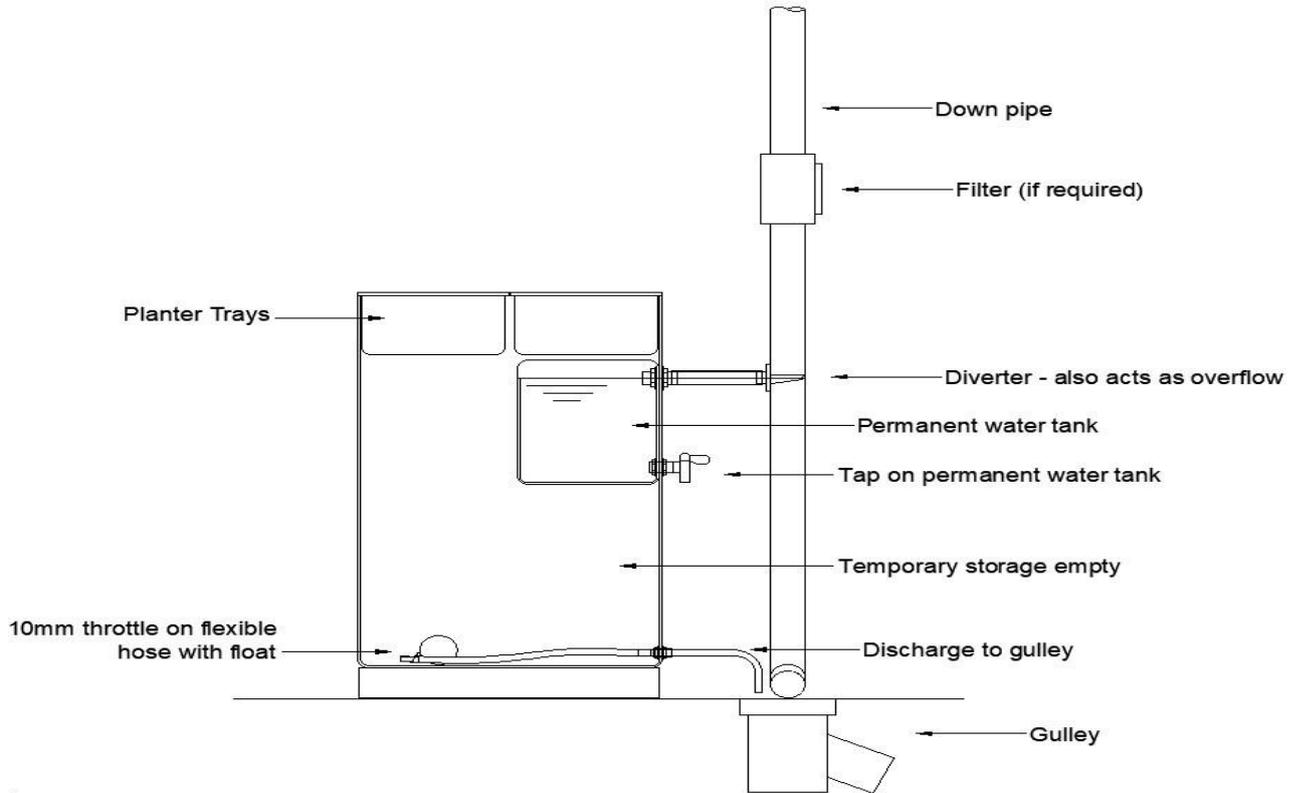
Planter operation

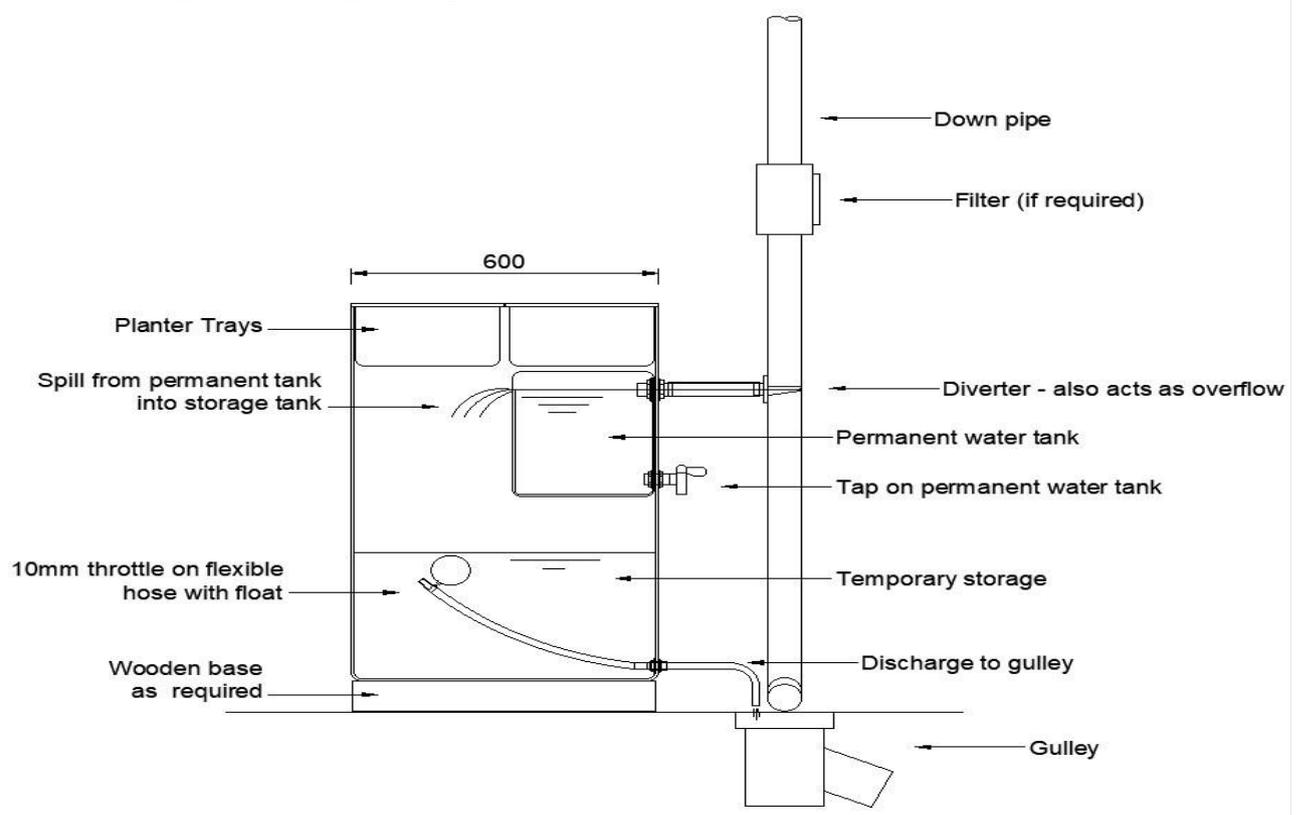
Planter filling/attenuating during rainfall
